**Docket No. 217 – Development and Management Plan Inspection**

Northeast Utilities Service Company Certificate of Environmental Compatibility and Public Need for the construction of a 345-kV electric transmission line and reconstruction of an existing 115-kV electric transmission line between Connecticut Light and Power Company's Plumtree Substation in Bethel, through the towns of Redding, Weston, and Wilton, and to the Norwalk Substation in Norwalk, Connecticut.

**Date:** March 23, 2005

**Location:** Norwalk Substation Expansion

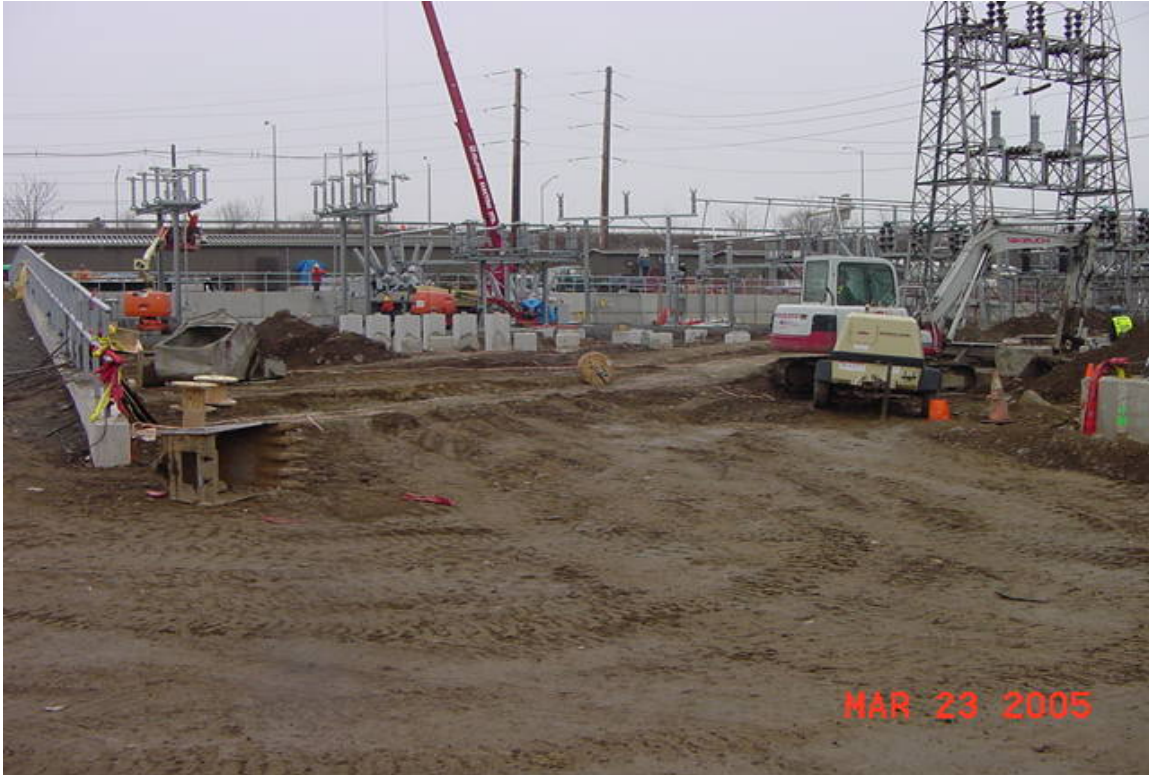
View of the construction of structures on the new footings, beginning within the expansion area below retaining wall #3. 3/23/05

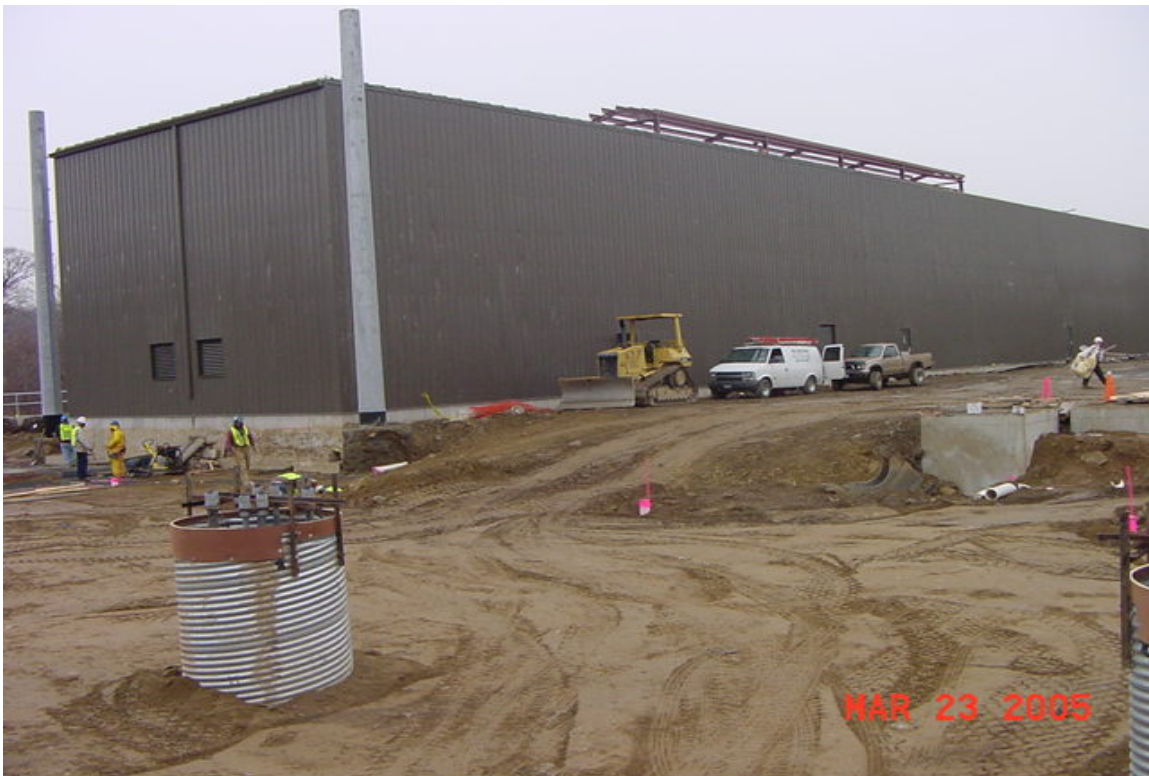
Siding and structure work continues on the GIS building. 3/23/05

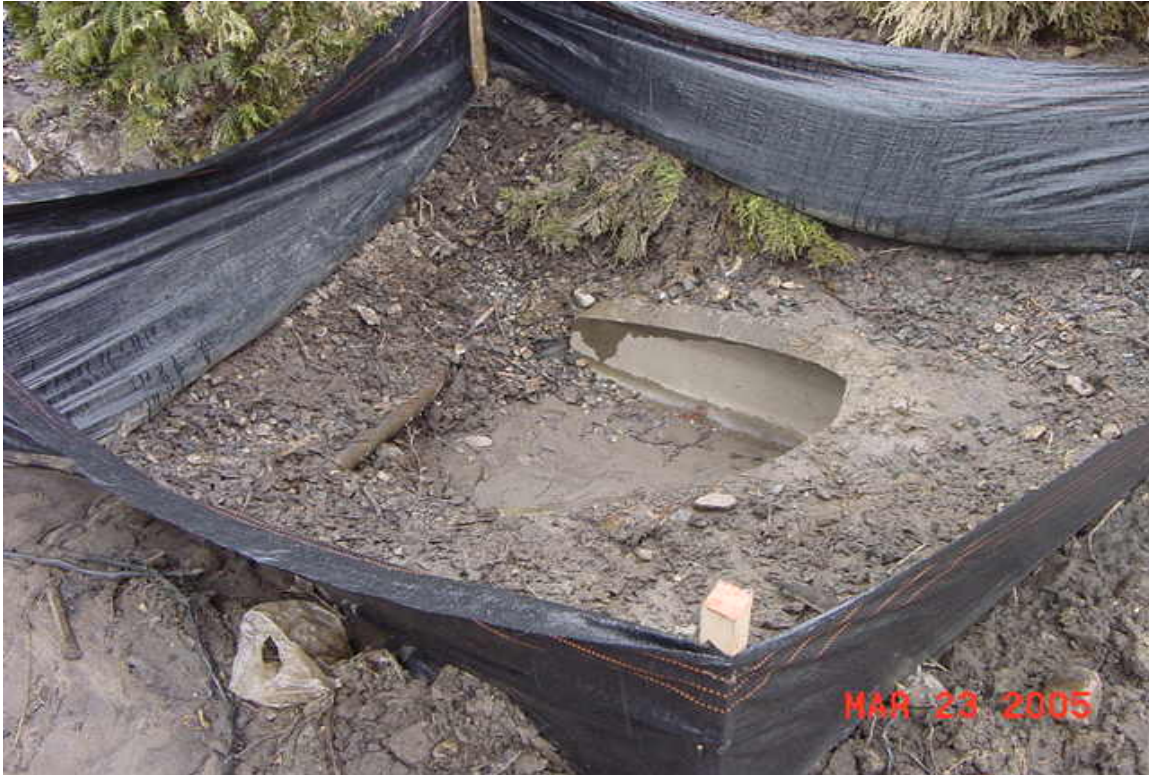
- The flared inlet near the Rt 7 ramp is receiving obvious stormwater flows from off site roadway and on site sources, and sedimentation is apparent here even with the existing controls. A haybale should be placed as an additional precaution. This will worsen with thaw periods. 3/9-3/23/05	- Continue to monitor until stabilized as the surrounding area is still bare soil. Until vegetative cover establishes, the potential for sedimentation in this area remains. A haybale check dam could also be placed in the earthen swale to slow sedimentation. 3/9-3/23/05

The inlet near the Route 7 ramp continues to receive on site and off site sediment despite the erosion controls in place. A haybale may help filter run-off here. 3/23/05

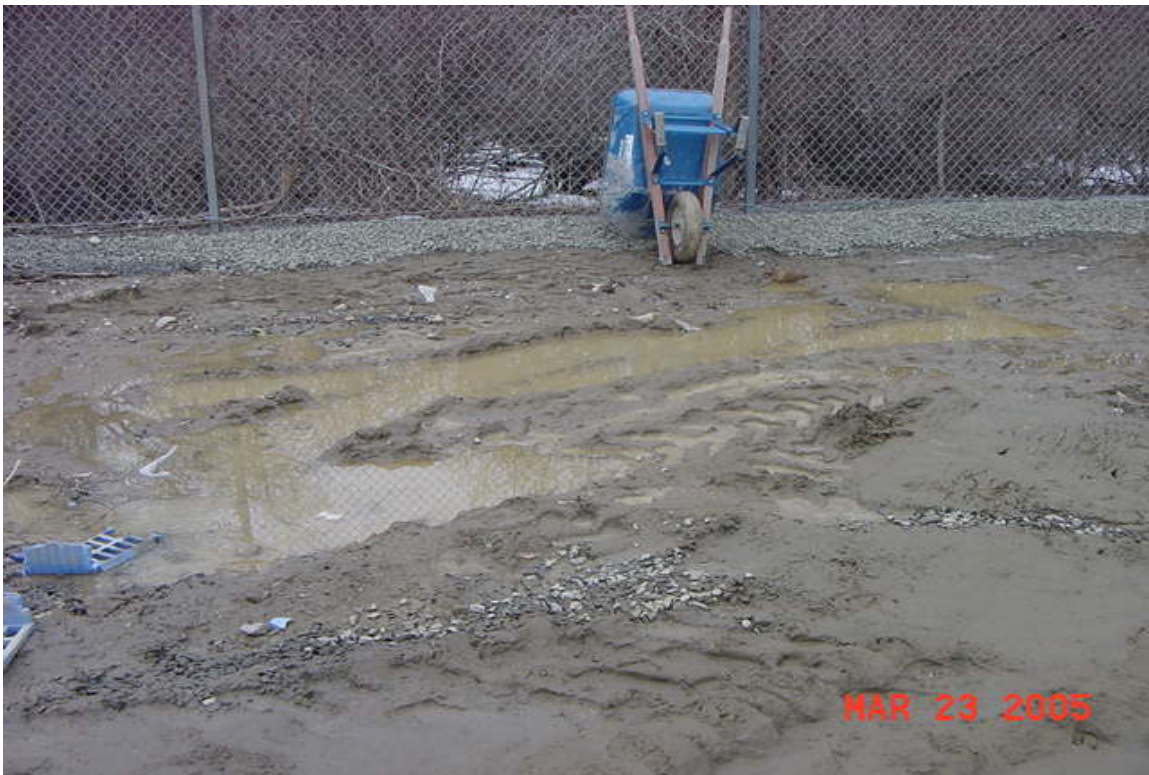
Areas of Inspection	Observation	Recommended Action
Erosion and Sediment Controls (includes inspection within 24 hours of a storm event)	- The working areas of the site are mostly muddy. The berm along the eastern perimeter fence was extended further as recommended with additional stone placed on the ends of the previous extension. 3/23/05	- Although the gradient of the site would typically drain water from this area, small isolated spots had pooled but are now contained from running off site. 3/23/05

Plumtree Substation: The area of new stone berm has been expanded along the perimeter fence and now prevents pooling water from leaving the site. 3/23/05

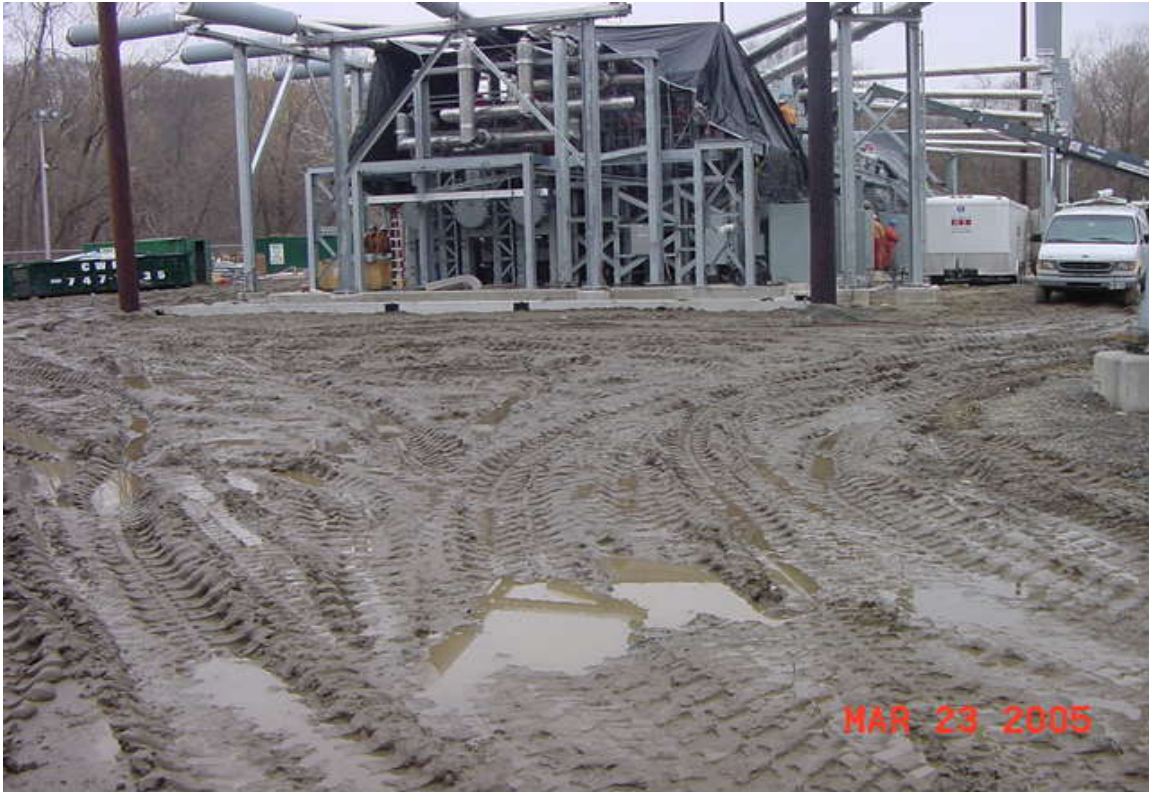
Surrounding trench work has been completed and internal construction continues on the slab. 3/23/05
